# Hobart Building Assessment Services

## Residential Pre-Purchase Inspection Report

Property Address: 2 Brown Street, No Town

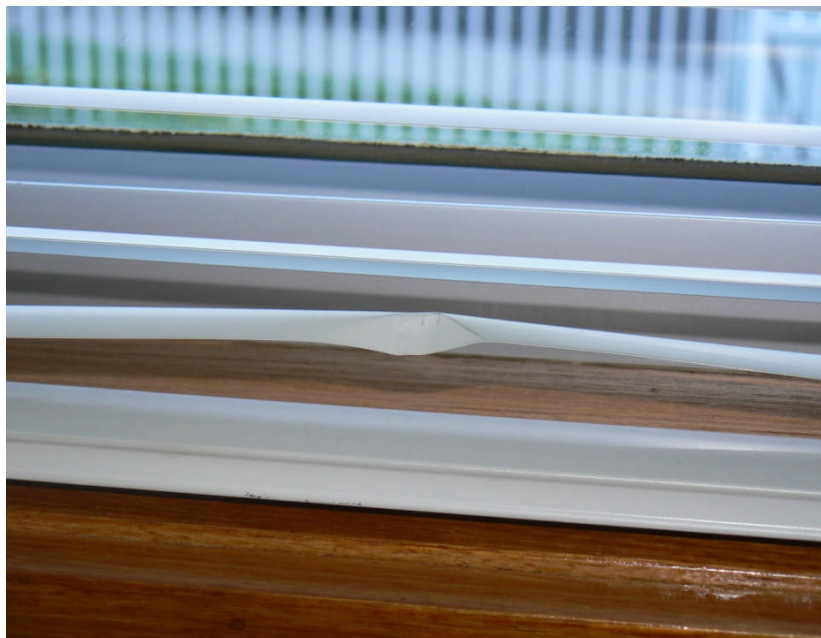
Blind

blind bent

minor defect

type B

**Interior - Bedroom 2 - crack in wall plaster and damaged blind slat**

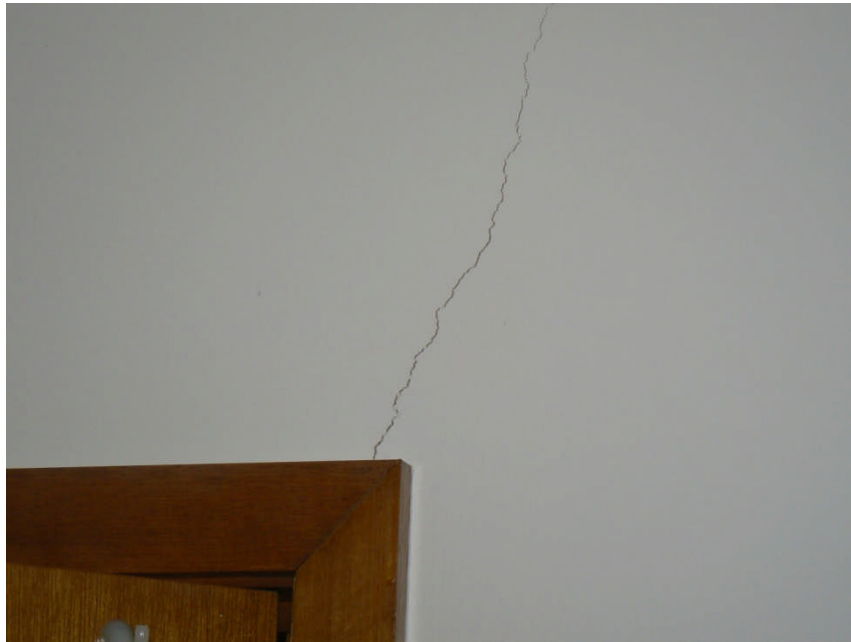
Wall

Plaster cracked

Minor defect

Type B

Damage category 2

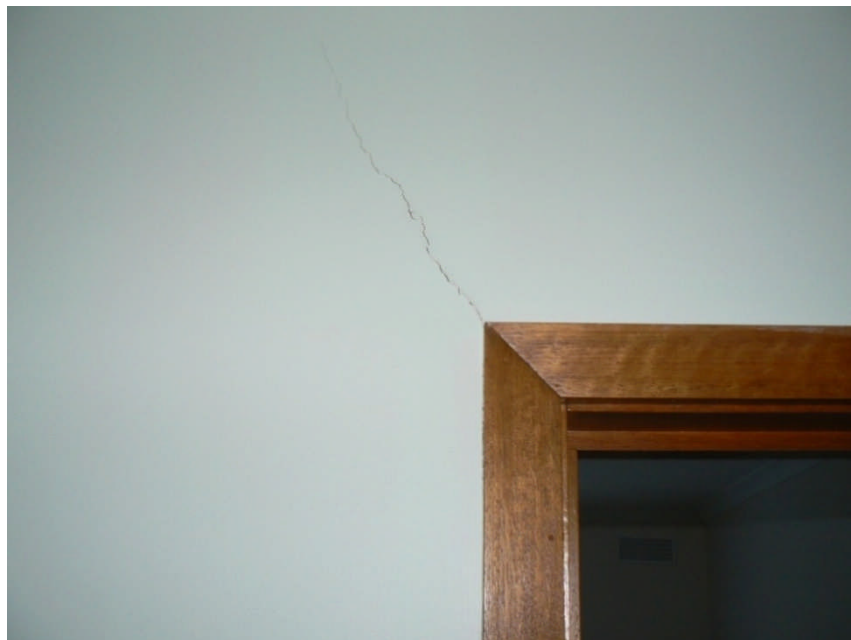
Wall

Plaster cracked

Minor defect

Type B

Damage category 2

**Interior – Hall - crack in plaster and damaged to security door flyscreen**

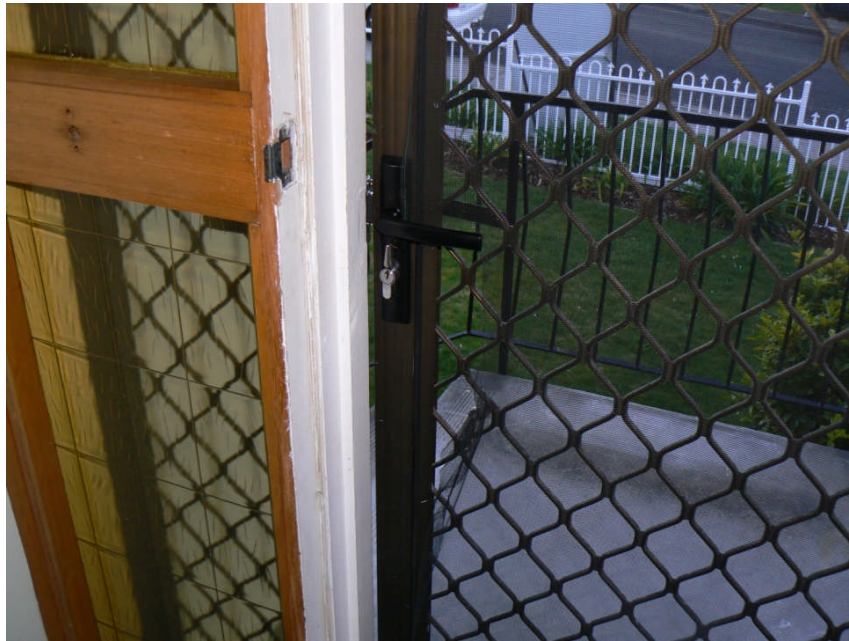
Front security door

fly screen damaged

Minor defect

Type A

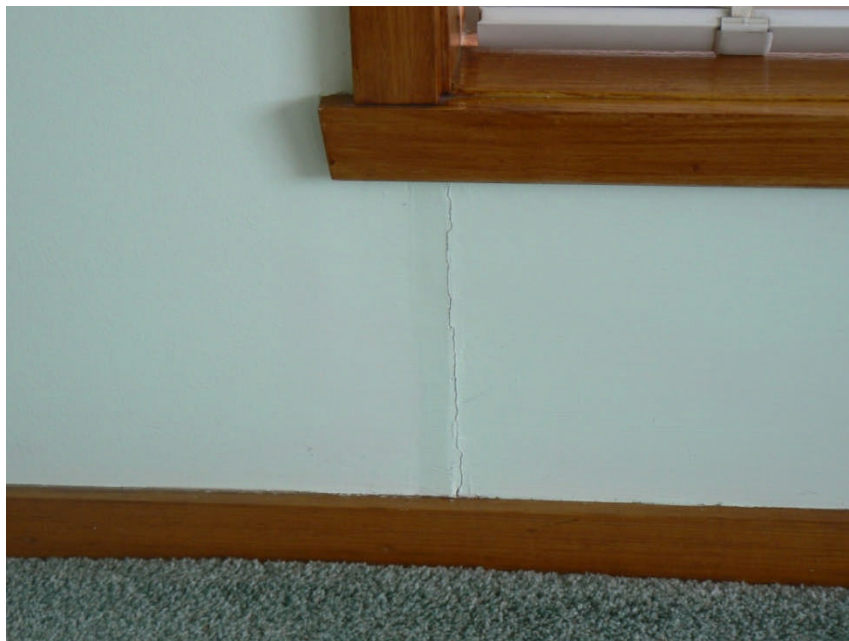
Plaster cracked

Minor defect

Type B

**Interior - Lounge room – walls - cracks in plasterboard**

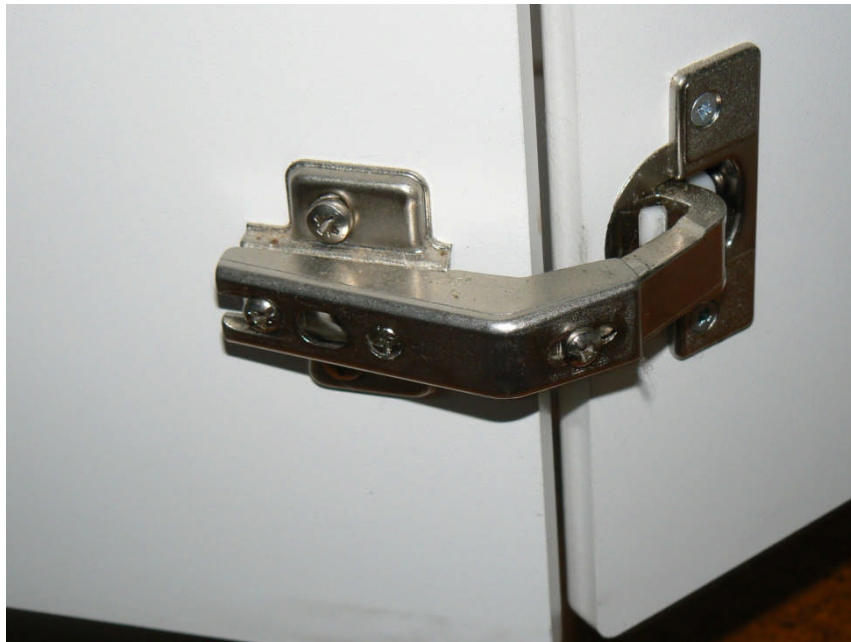
Corner Cupboards

Hinges loose

Minor defect

Type B

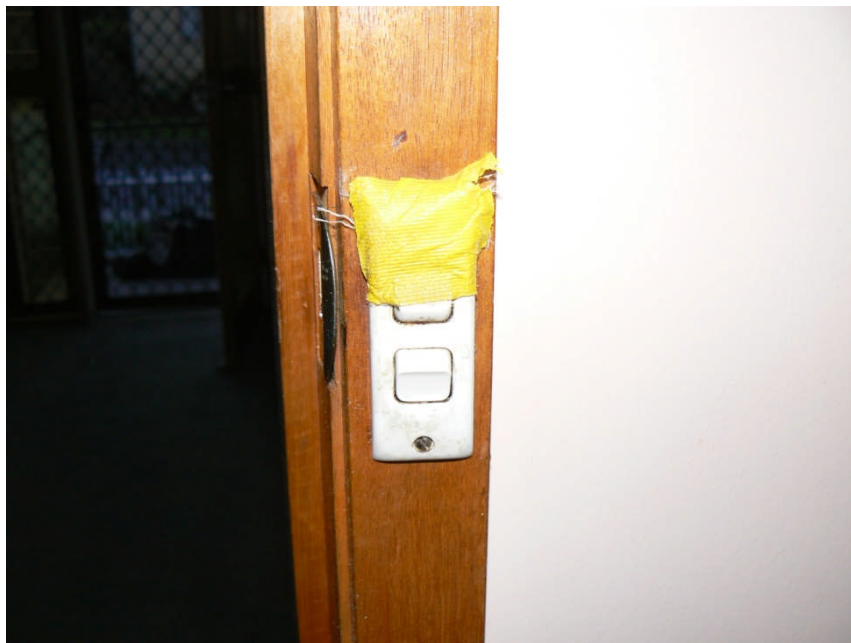
Light Switch

Top switch taped over

Minor defect

Type A

**Interior – kitchen - taped up light switch and loose hinges on corner cupboards**

*Recommend referring matter to electrician*

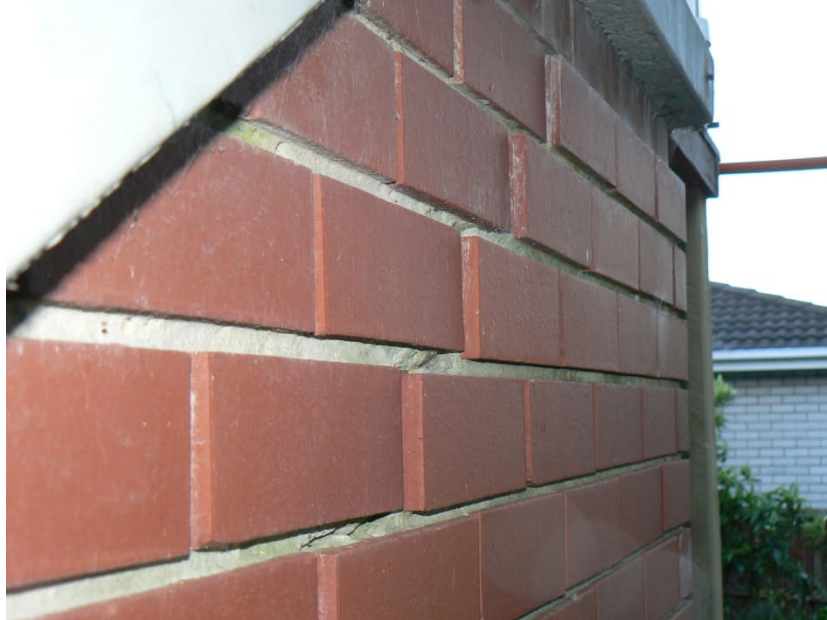
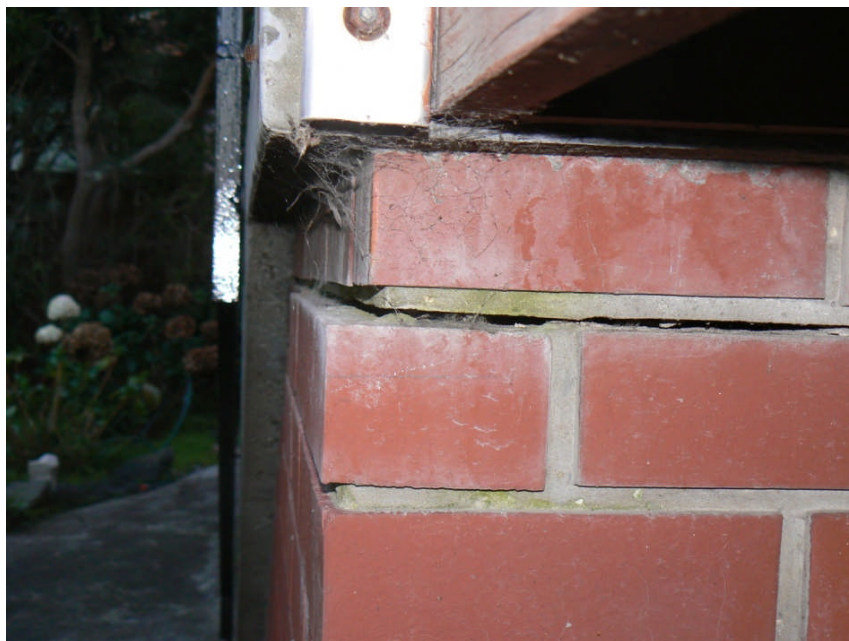
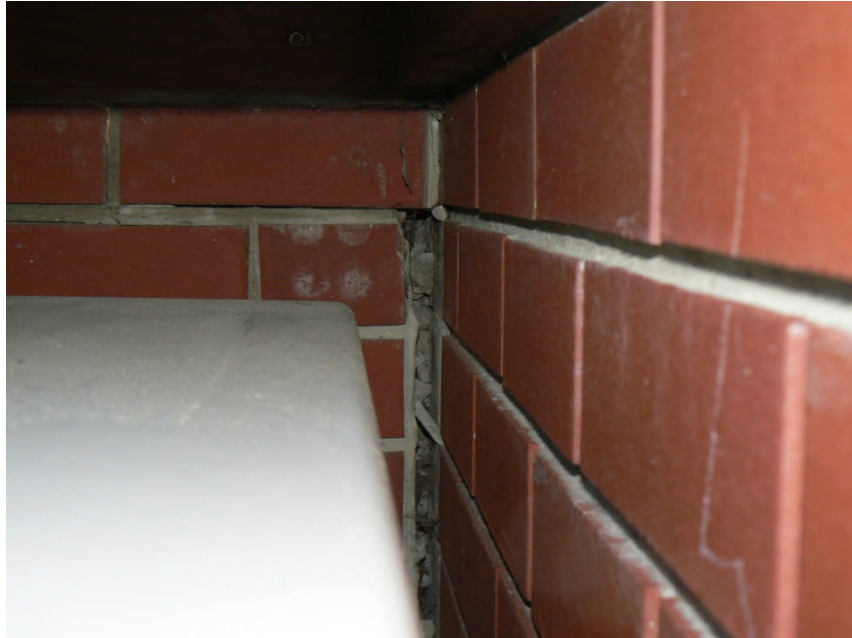
Brickwork under back door concrete landing has moved and large cracks are evident

Major defect

type B

Defect significance

FI

**Exterior - Brickwork under rear concrete landing - evidence of substantial cracking and movement.**

*Recommend wall area be looked at by structural engineer*

*Recommend engaging structural engineer for assessment of structural damage*

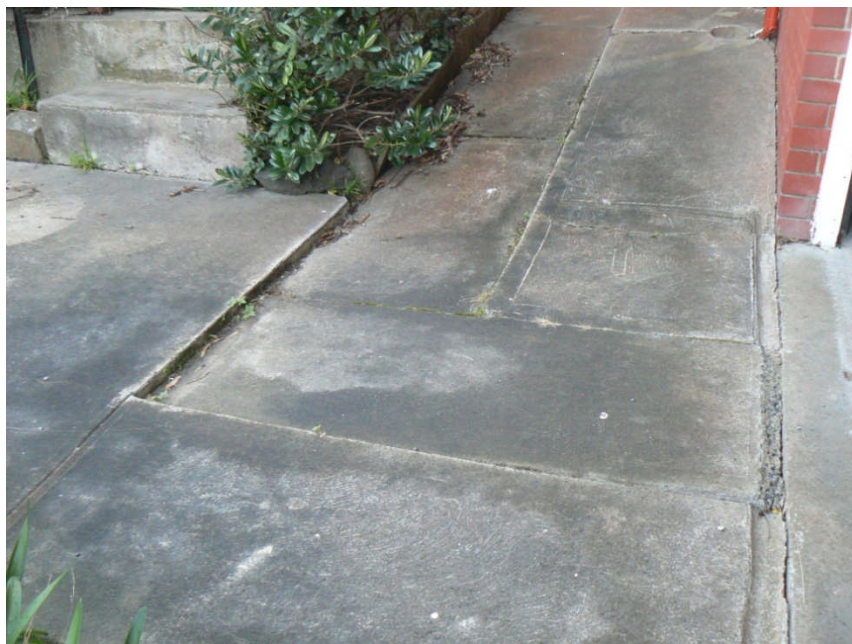
Paths cracked and evidence of consolidation in some areas

Minor defect

Type B

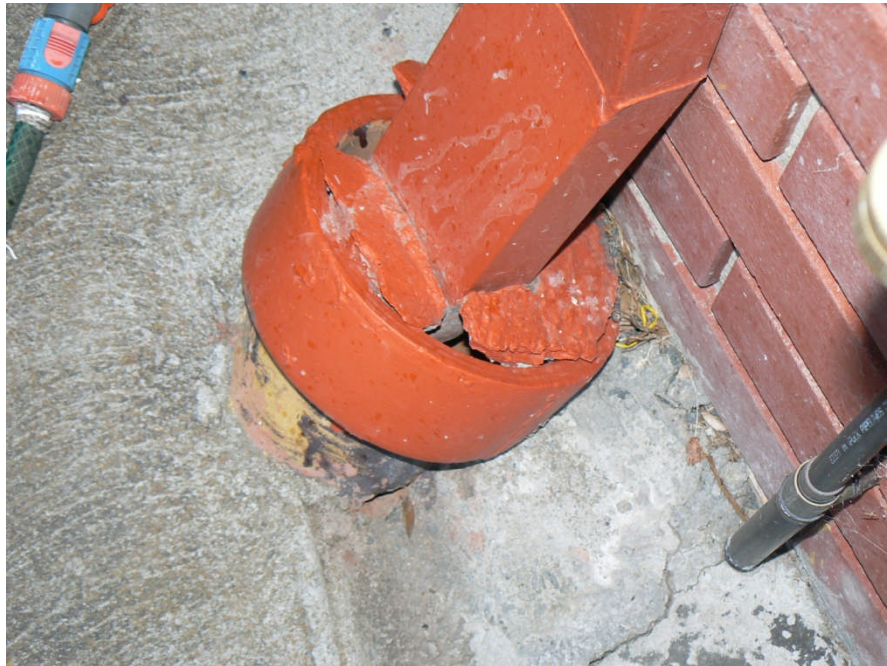
Stormwater pipe - cement cracked at earthenware pipe junction

Minor defect

Type B

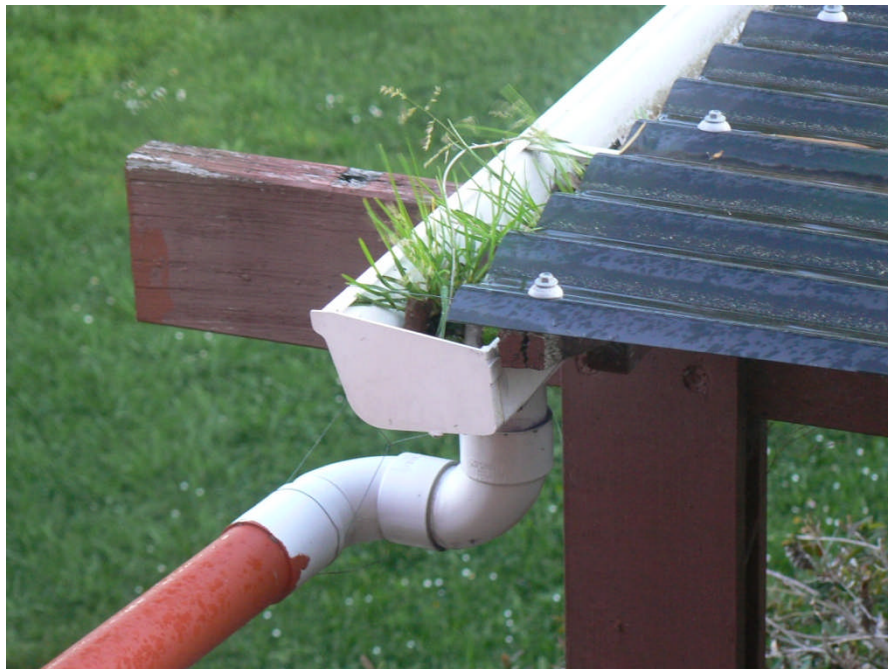
Gutter blocked at down pipe

Minor defect

Type D

**Exterior - Pergola - blocked gutter at downpipe.**
